## **Swift-E Release Notes, Firmware Version 1.001**

**Issue Date:  
22nd April 2020**

These release notes correspond to firmware version 1.001 of Odos Imaging Swift-E.

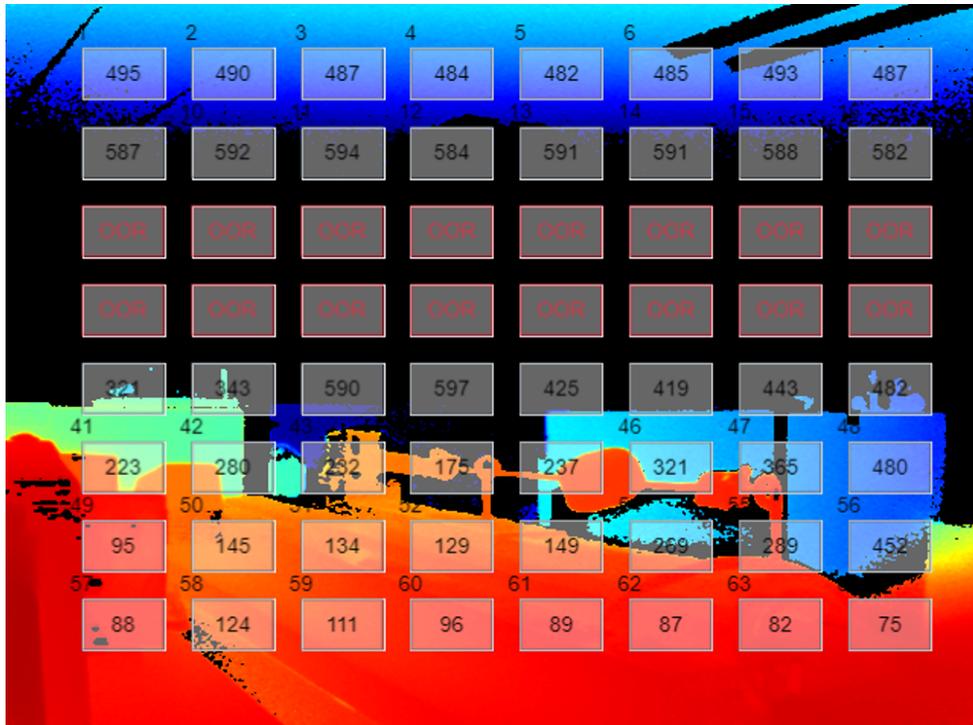
#### 4.9 Measurements above 6 meters (~20ft)

When the device is measuring an open space beyond 6 m, the returned signal weakens fast and the values displayed are smaller than expected. This is due to the weak signal returned but can be removed using the **Signal Strength Threshold**.

Figure 1: Use **Signal\_Strength\_Threshold** to ensure measurements over 6m are invalidated

Increasing this Advanced Parameter will allow to filter signal that is too weak to produce a valid measurement. By increasing **Signal Strength Threshold**, some sensors may display an Out of Range (OOR) value in the screen (999 in the controller) - distance points in these VSZ are not capturing sufficient signal for a measurement.
